1. AGENCY USE ONLY (Leave blank)		2. REPORT DATE January 1998	3. REPORT TYPE AND DATES COVERED Final 1 Feb 1995 - 30 Sept 1996	
4. TITLE AND SUBTITLE Surface Treatment of High Performance Marine Alloys to Enhance Crevice Corrosion Resistance in Critical Seawater Applications			5. FUNDING NUMBERS C N000144-95C-001

6. AUTHOR(S) Robert M. Kain				
7. PERFORMING ORGANIZATION NAME(S) AND ADDRESS(ES) LaQue Center for Corrosion Technology, Inc. 702 Causeway Drive, Post Office Box 656 Wrightsville Beach, North Carolina 28480			8. PERFORMING ORGANIZATION REPORT NUMBER

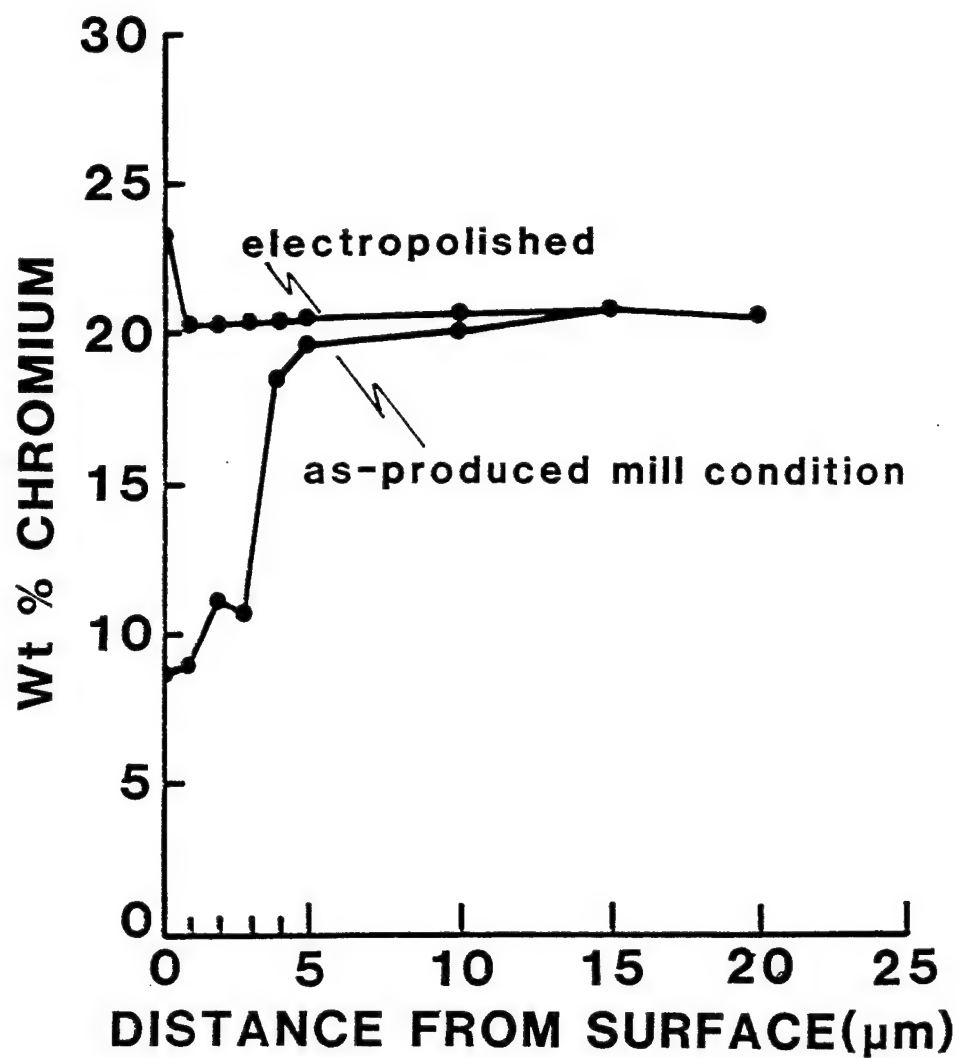
Figure 23. SEM/EDS profiling analyses of cross-sectioned N06625 pipe with and without electropolishing.

Samples of the as-produced and electropolished (ID/OD) test pipes were subjected to Scanning Electron Microscope/Energy Dispersive Spectroscopy (SEM/EDS) analyses by the same equipment and profiling technique employed in the previously reported study by Oldfield.<sup>9</sup> Analyses of the OD pipe surfaces were also performed. Results of the profiling analyses for chromium are plotted in Figure 23 as a function of distance inward from the edge of the cross-sectioned material. As can be seen, the analyses show considerable chromium depletion at the OD edge of as-produced pipe, and some enrichment at the OD edge of the electropolished pipe. The degree of depletion shown in Figure 23 is considerably greater than that described earlier by Oldfield<sup>9</sup> for mill pickled sheet material of the same alloy. At a profile depth of about 15 $\mu$ m, and inward, the level of chromium analyzed for both the as-produced and electropolished pipes approximated, within 1%, the actual level shown for the mill heat analysis. The above depth of chromium depletion at the surface of the as-produced pipe appears consistent with the near surface feature shown in the 1000X optical photomicrograph in Figure 1b.

According to literature provided by the electropolisher, this process involves removal of less than 1 mil ( $\sim 25\text{ }\mu\text{m}$ ) of material; more typically about 0.4 mils ( $10\text{ }\mu\text{m}$ ). By reference again to Figure 23 and Figure 1b, it is apparent that this was sufficient to remove the chromium depleted surface layer in the as-produced N06625 pipe tested. Figure 23 may also be useful in explaining the limited penetration ( $\leq 0.01\text{ mm}$ ) which occurred at all the affected sites on the as-produced pipe specimens exposed to cold natural seawater and to chlorinated seawater. Conceivably, as the initial attack following breakdown of passivity deepened it was confronted by the increasingly more corrosion resistant composition. As illustrated previously by Figure 23, this more resistant composition begins, in this material, at a profile depth of about  $4\text{ }\mu\text{m}$  ( $0.004$  or  $<0.01\text{ mm}$ ). The occurrence of substantial deeper attack at several affected sites in the warm seawater tests is not consistent with the above discussion regarding gradations in material resistance from the surface inwards. Because chromium is considered to be a major contributor to the fall in pH within the crevice,<sup>10</sup> exposure to the higher chromium containing material below the now-removed depleted layer may have contributed to the development of a more acidic crevice environment, and hence greater propagation. However, the existence of high levels of chromium at the surface of the resistant electropolished specimens was shown to provide greater resistance to the anolyte investigated. It is

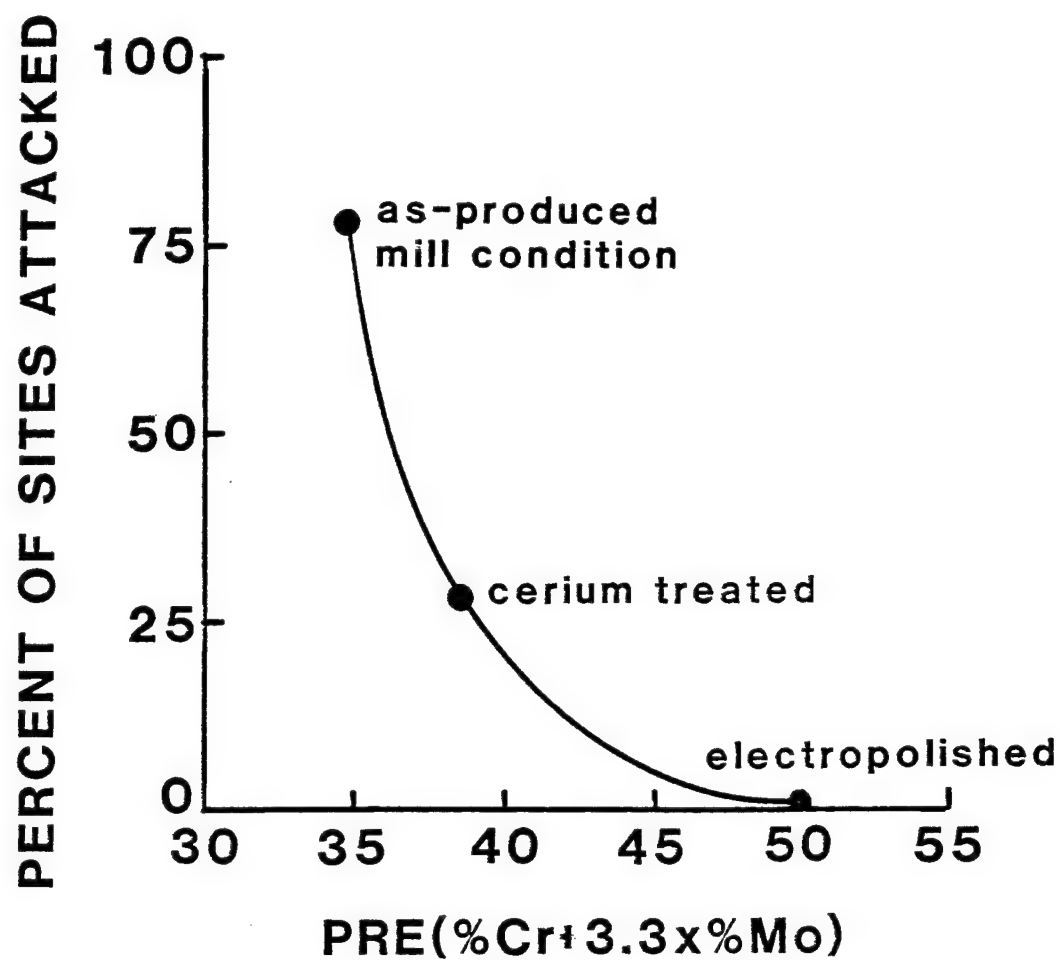
Figure 24. Relationship between surface PRE value and total number of N06625 crevice sites attacked in various seawater tests.

Figure 24 provides a plot showing the relationship between the calculated PREN values, from adjusted EDS data, and the total number of affected crevice sites in all natural and chlorinated seawater tests discussed earlier in this report. For this example, results for cerium A and cerium B treated material have been averaged, as were those for the two series of electropolished pipes. As can be seen, the propensity for crevice corrosion initiation decreased with an increase in the value of PREN, as would be expected for similar comparisons of alloys with different bulk analyses. While the greatest benefit was associated with electropolishing, the influence of the applied cerium treatments was also substantial. The enhanced resistance provided by both the cerium (A and B) treatments and electropolishing in terms of crevice corrosion initiation can be related to the resistance of the respective materials in aggressive crevice electrolytes. Figure 25, for example, shows a plot of the

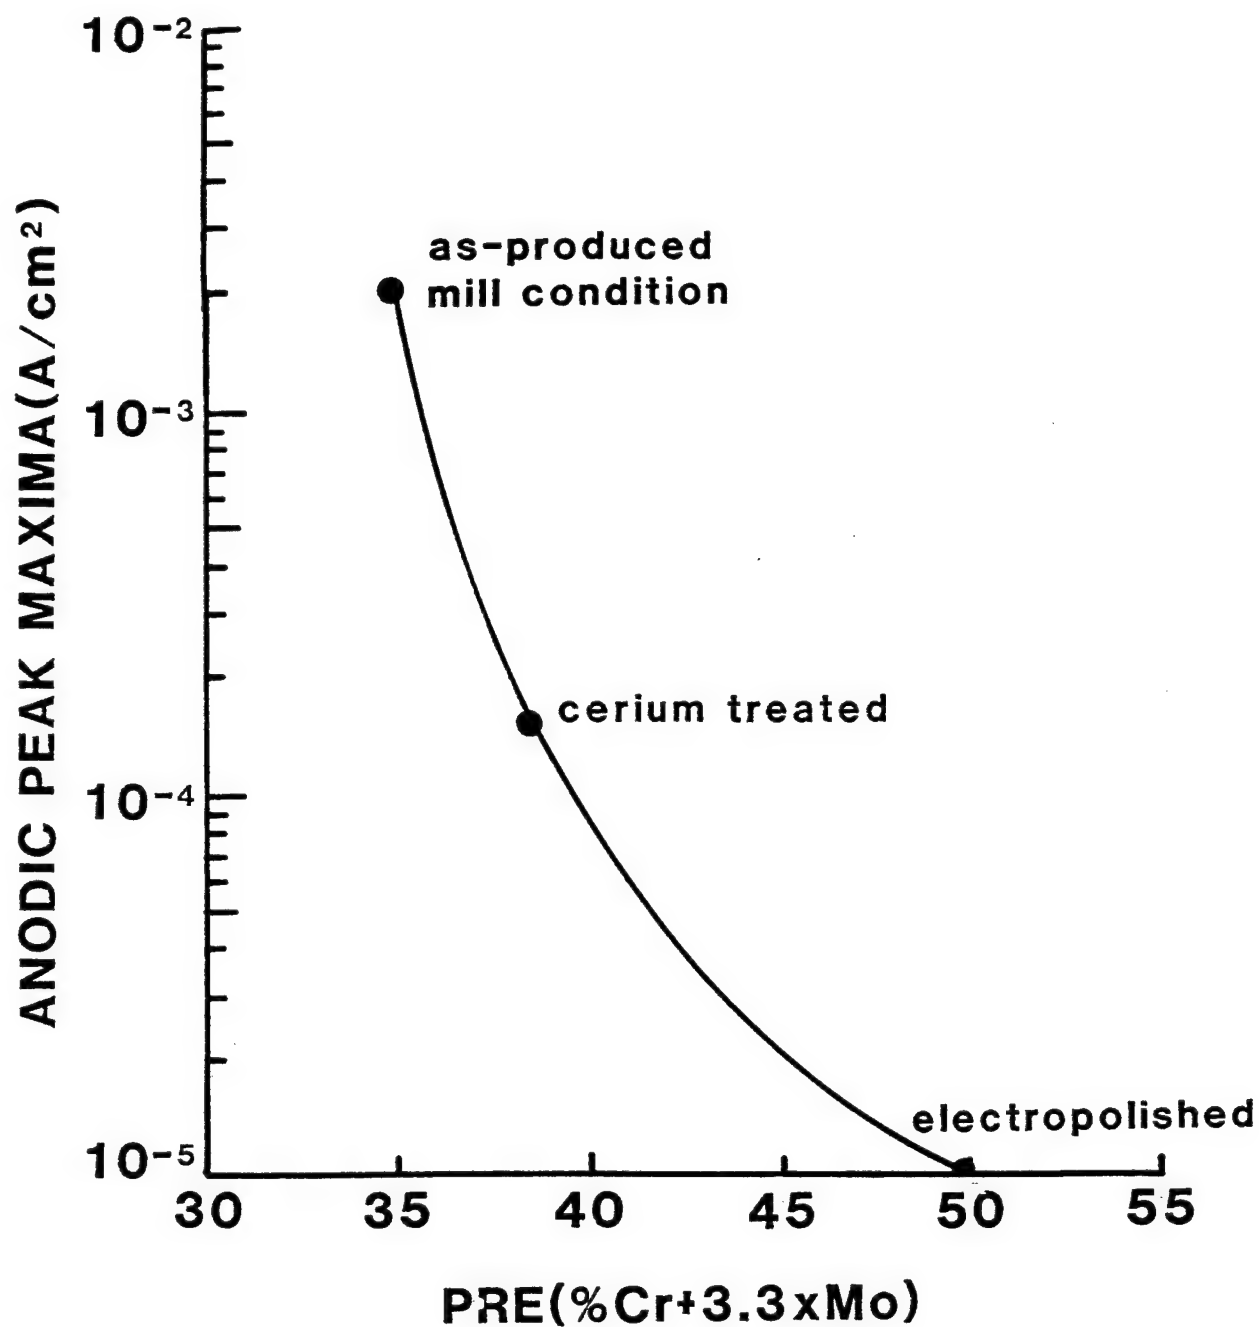
Figure 25. Relationship between N06625 surface PRE value and anodic current maxima determined in deaerated, simulated crevice solution at  $\text{pH}=0.2$ .

anodic peak current maximum (from Figure 21) as a function of the PREN values developed from adjusted surface EDS data. As can be seen, one to two orders of magnitude improvement in resistance over that for the as-produced material is shown for the cerium treated and electropolished material, respectively.
